CONSERVATION ECOLOGY PROJECT

SHEEPWASHES OF THE WESTERN LAKE DISTRICT VALLEYS

By Steve Clarke

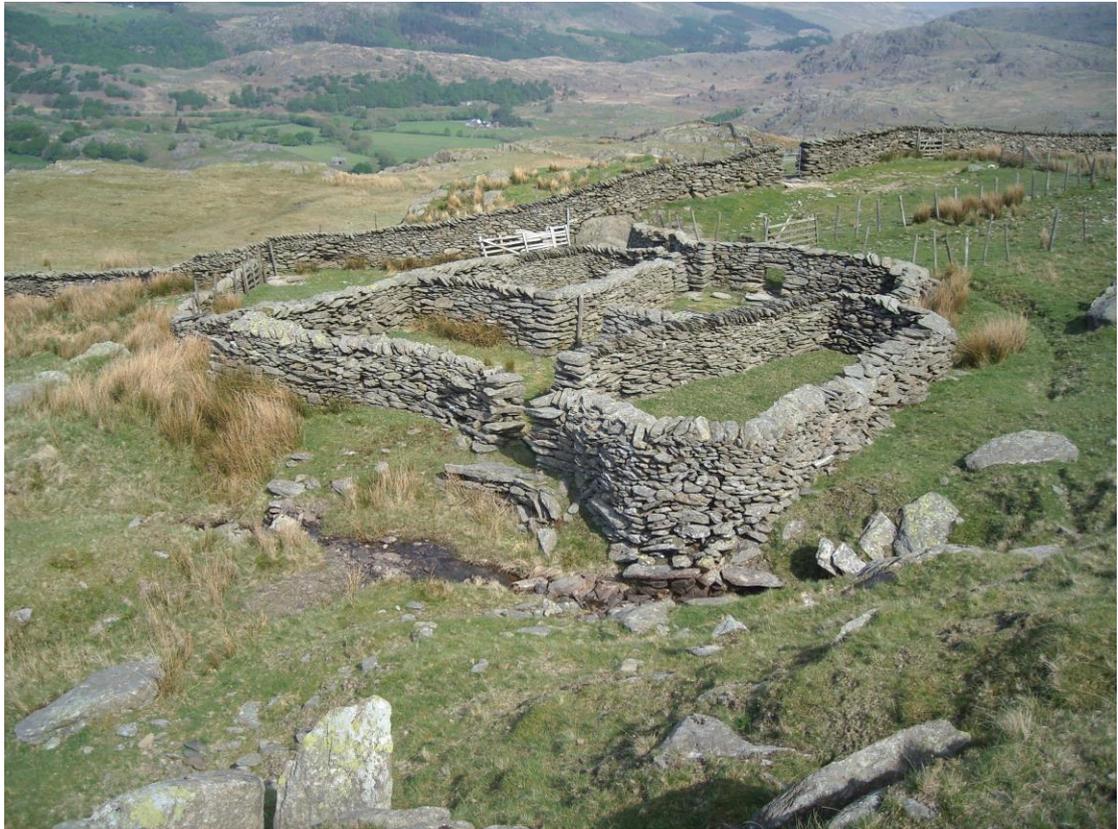
PLATE1

WALNA SCAR QUARRY SHEEPWASH, DUDDON VALLEY

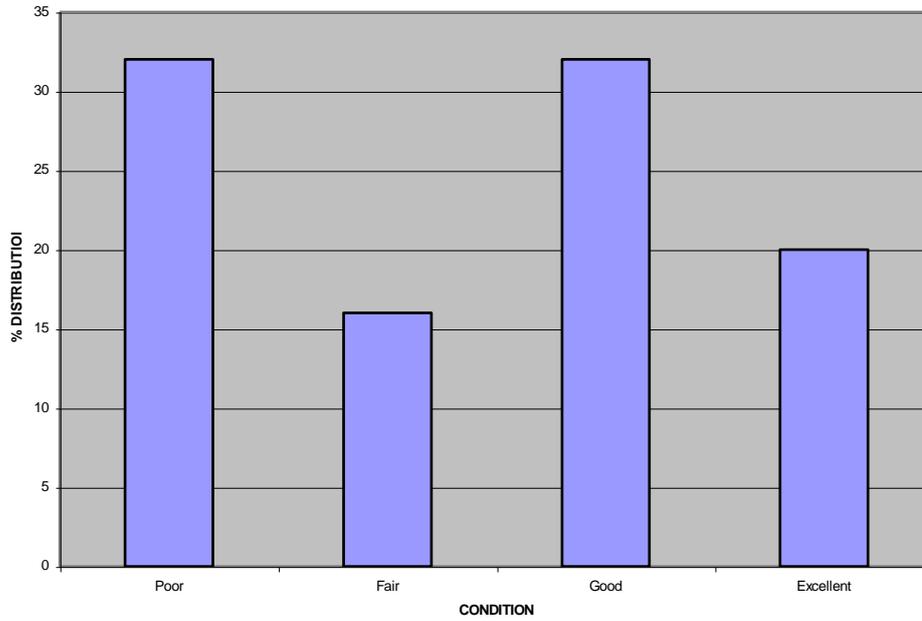
The following bar chart shows the distribution of structure condition as defined in Appendix 2.

Sheepwashes in the study area are generally in an intact condition and their purpose is clear to the experienced eye. 68% were in fair, good or excellent condition with 52% being good or excellent. Only three sites were found totally destroyed without trace. This part of our agricultural heritage has survived well, probably because most are in relatively remote locations. Survival is also a function of build quality and structures in parts of the Duddon and Annas valleys where the country rock is poor quality slate have suffered accordingly.

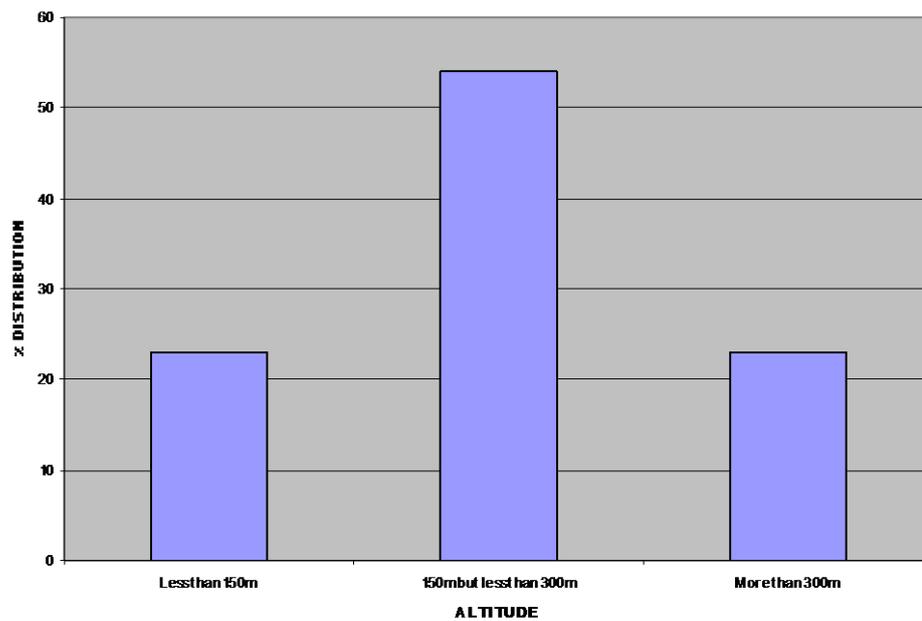
The following bar chart shows the altitude distribution at which structures are located

There is a clear link between the altitude at which sheepwashes are located and landscape location. The majority (55%) are located between 150m and 300m altitude with 63% located against the enclosure head wall or on open fell relatively close to it. Utilising the head wall as part of the structure saves construction effort and if the enclosure award documents for such locations can be traced a more accurate construction date may be ascertained.

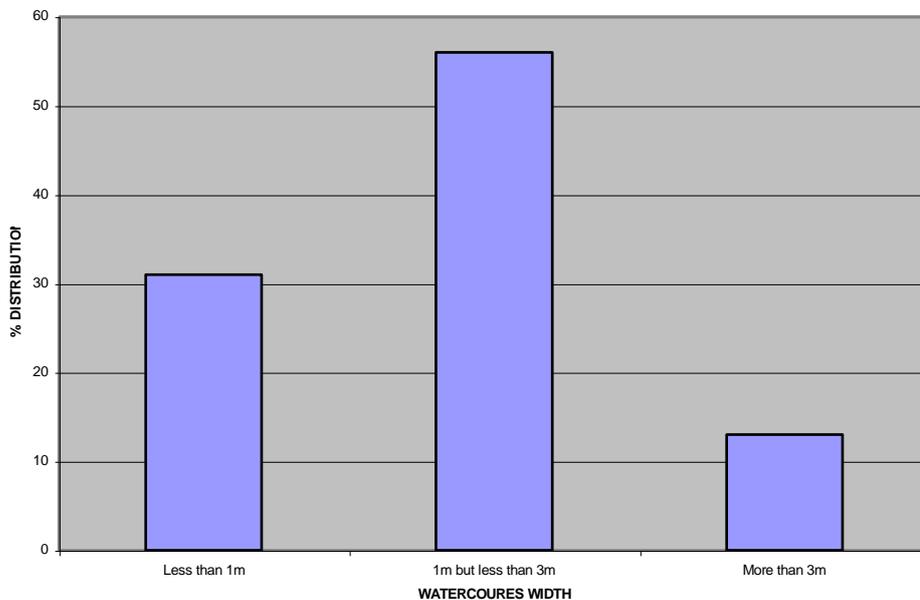
The chart below shows the distribution by width of watercourse on which a sheepwash is located

There is a clear trend for sheepwashes to be built on watercourses that are no more than 3m wide, with the majority on watercourses between 1 to 1.5 m wide. In many cases this is a function of the decision to build around the headwall at 300m altitude where watercourses tend to be in their infancy. However I believe another factor is that whilst not much water is required to operate a sheepwash effectively once the dub is filled, there is evidence that structures on larger watercourses have suffered damage or total destruction due to floods (especially where they are located on the outside of bends) and so construction on larger rivers has been avoided.

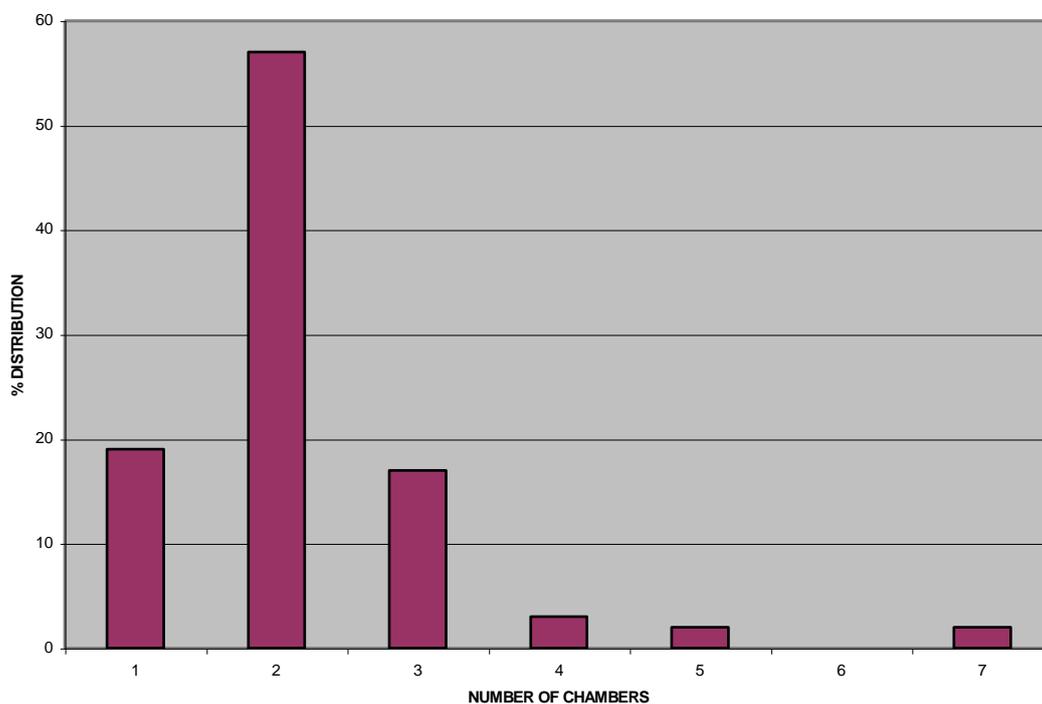
Wash folds within the study area were found to have between one and seven compartments or chambers as illustrated in the bar chart below.

76% of the sheepwashes were single or two chambered structures with the majority (57%) being two chambered.

The single chambered design was relatively quick to build and functional as a washing structure whereas the two chambered design enabled sheep to be driven in a receiving chamber first and from there released into the washing chamber in a more controlled manner. Other sheep management tasks could also be carried out in the receipt chamber prior to washing.

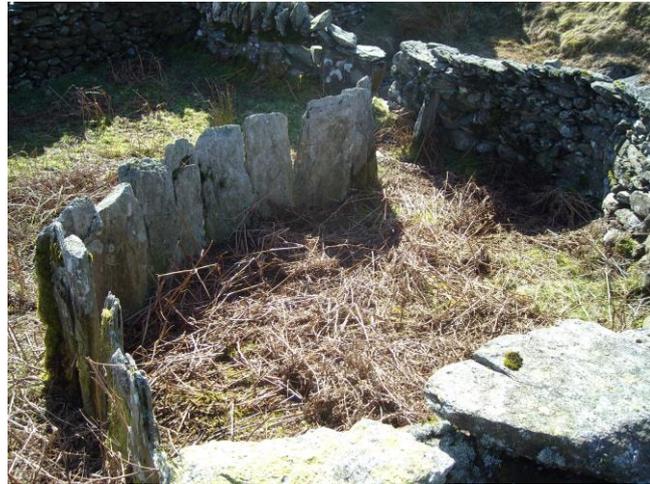
Figure 1
Structure L02 Tail Crag
(Caw)
Compartment walls
formed by Interlocking
slate flags

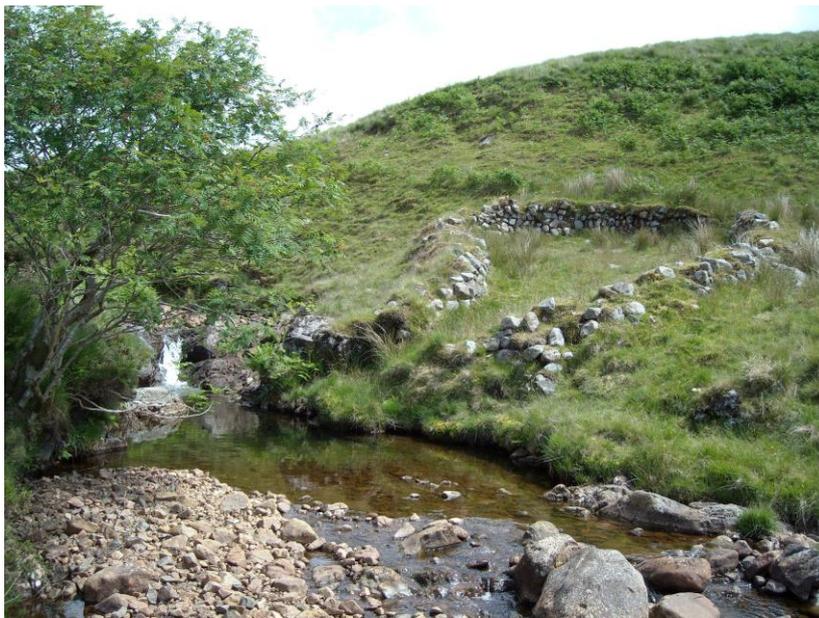
Differences in building style reflects both local geology and vernacular style. The vast majority of structures were built in the standard dry stone wall style. However a small area of the central Duddon valley either side of Caw uses large vertical interlocking flags of slate dug into the ground to form partitions (e.g. structure L02 figure 1) and structures in parts of the Calder catchment are built using the west Cumberland stone and turf dyke (e.g. structure C01 figure 2).

Figure 2
Structure C01
Stockdale Moor
Built in the West
Cumberland stone
& turf dyke style

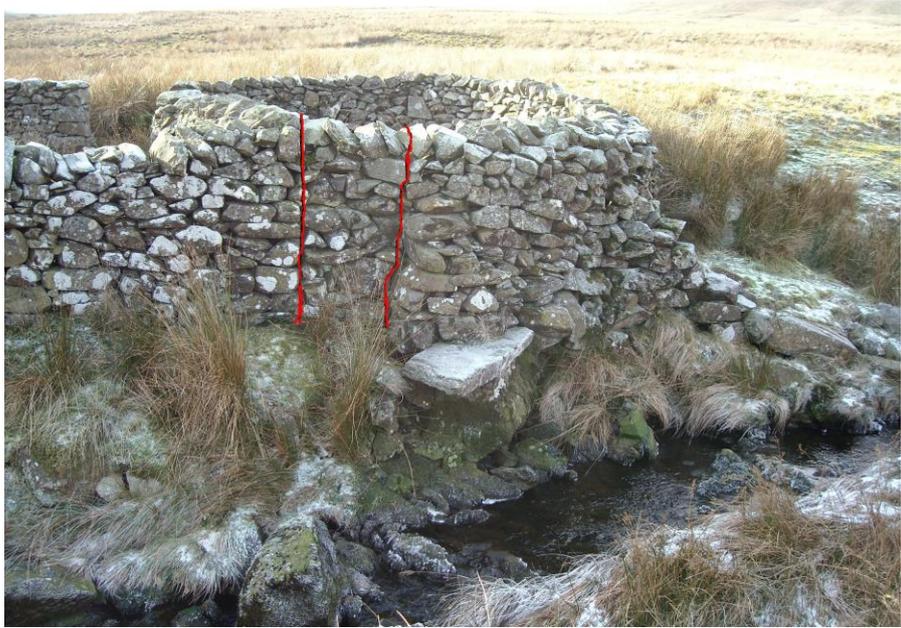
The most common modification (e.g. structure D19, figure 3) has been to wall up the exit gate to the washdub thereby making the structure into a standard containment fold.

Figure 3
Structure D19
Thwaites Fell
Exit door to dub
walled up, location
shown in red

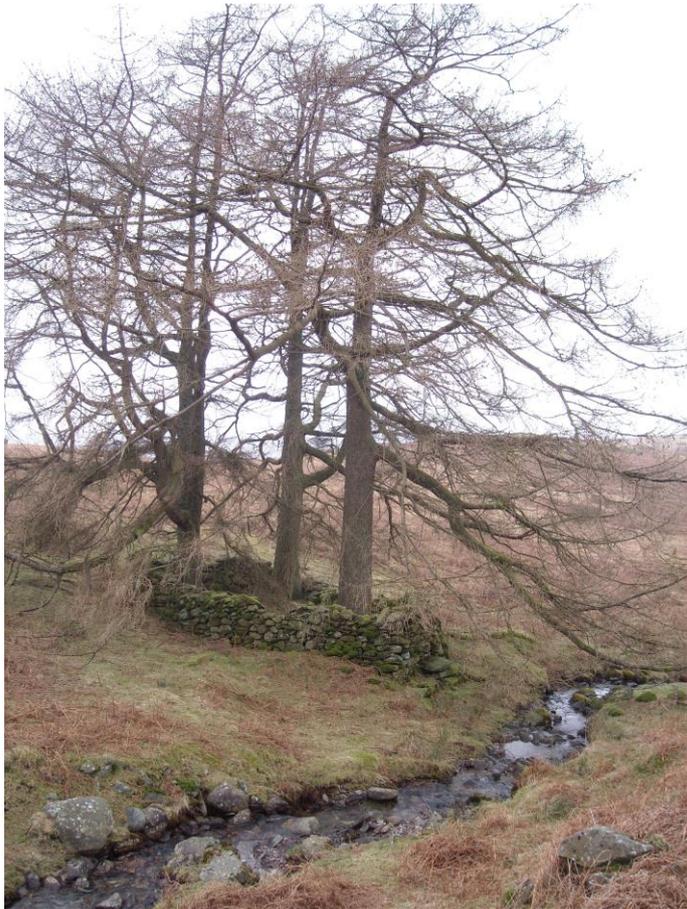
Two structures (D23 figure 4 and part of D21) had inlet and exit gates walled up to create a sheep proof enclosure within which trees were planted. In both cases the trees are large and mature indicating the enclosure was formed many decades ago.

Figure 4
Structure D23 Park
Head Road North
Inlet and exit gates
walled up to create
sheep proof tree
enclosure

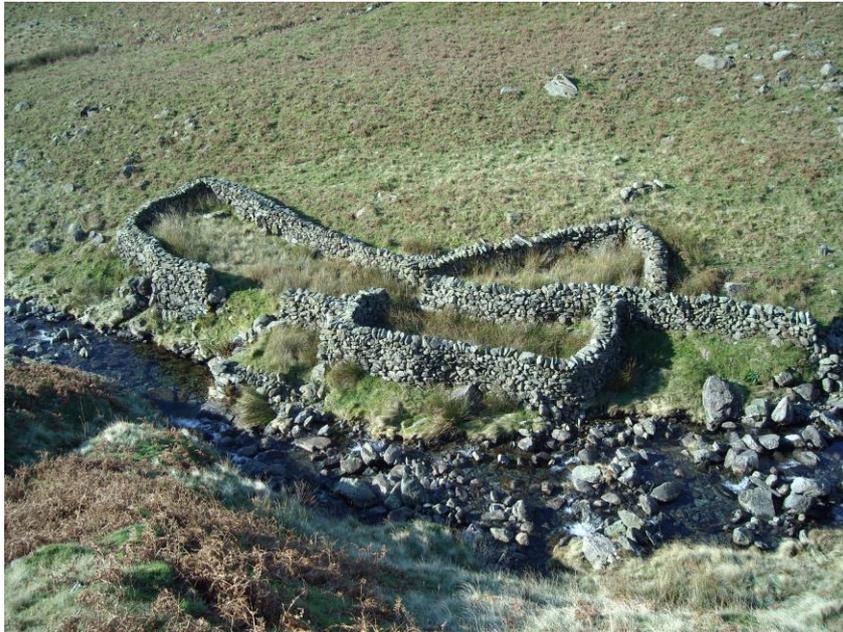
Three structures have been ‘conserved’ by rebuilding. One of these (structure I04 Figure 5) has been very well done, but the other two (structures E17 and D12 figure 6) have failed to appreciate, or ignored the fact these were sheepwashes unfortunately resulting in the structure being rebuilt as a standard containment fold rather than a sheepwash.

Figure 5
Structure I04
Overbeck
Example of a
sympathetically and
well conserved
sheepwash

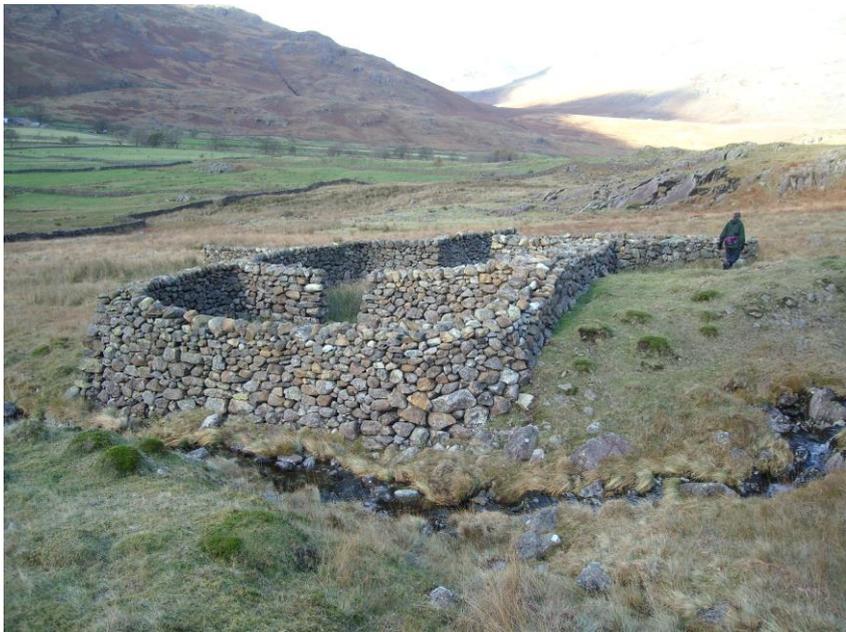
Figure 6
Structure D12 Dale
Head
Example showing
structure incorrectly
rebuilt as a fold with
former exit gate
located centre of
nearest wall walled up

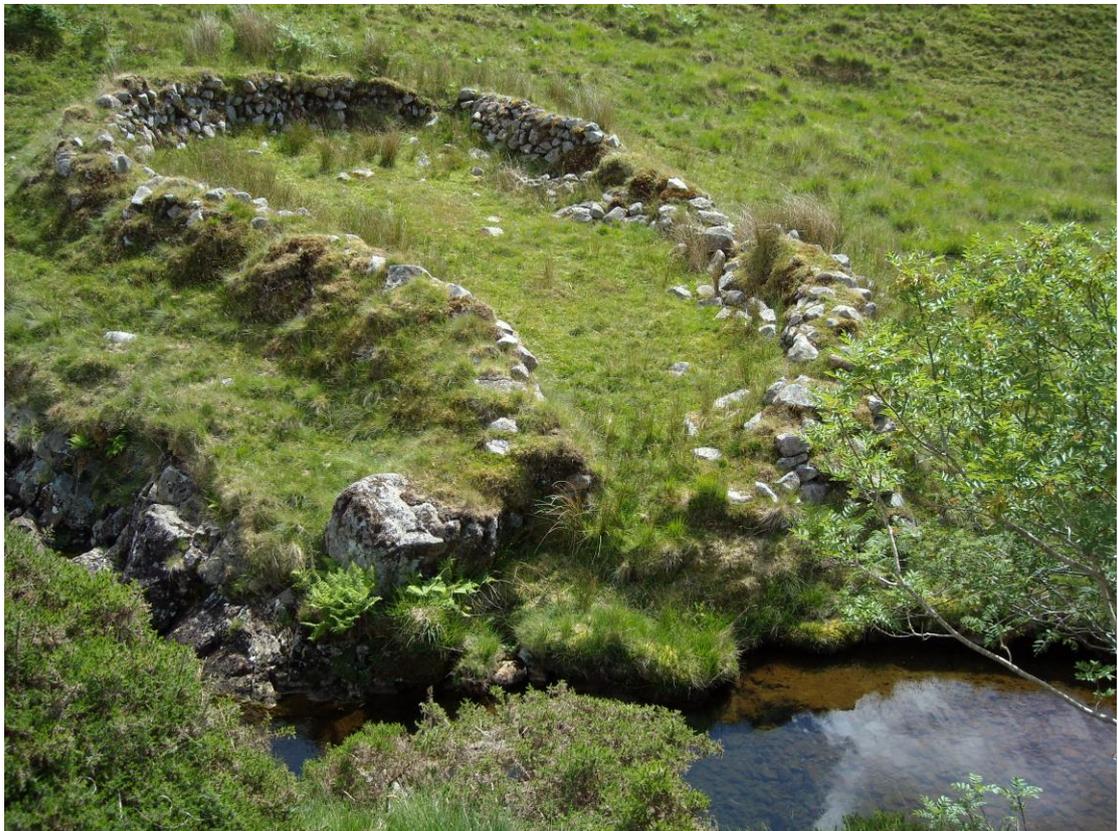
PLATE 2

STOCKDALE MOOR SHEEPWASH
