**DVLHG/LDNP Shard Fencing Survey. 2024**

Date: 22.06.24	Location: Sheepfold Park Head Road	Ref: F5
----------------	------------------------------------	---------

Purpose:	partition wall across sheepfold chamber	How made?	X - report if machine cut
			no

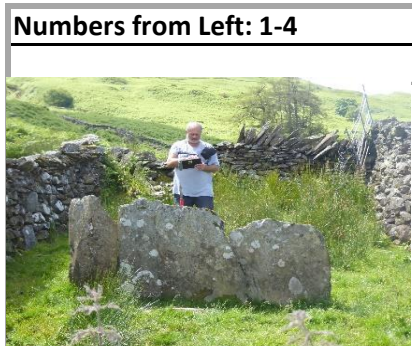
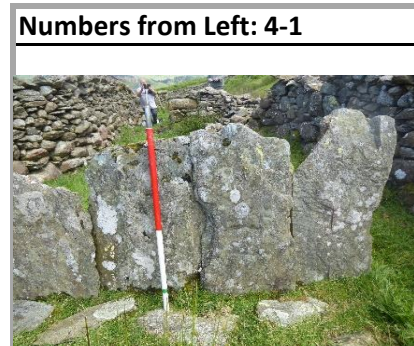
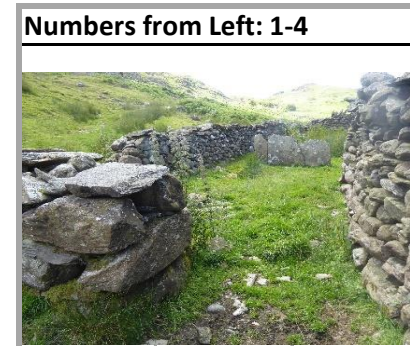
Dimensions (cm) (Numbered from left): Sample 10 - every \_\_\_\_\_ slab

Number:	1	2	3	4						
Height:	98	102	97	86						
Width:	47	42	65	85						
Thick:	7	5	8	9

Overlapping sample - pick sets of THREE to sketch here. Photograph sets of three slabs at a time - use white boards

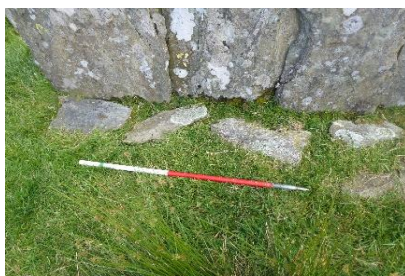
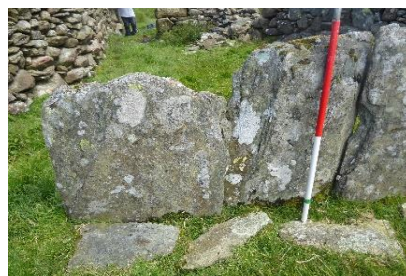
Sketch any interesting features:

Central partition in sheepfold. Map shows a continuous wall across the chamber but there are spaces either side of the shards. The south end of the fold is filled with rushes. Stones laid flat on the ground on both sides of the shards. Not seen that anywhere else
